Manhole Inspection Summary

Manhole # **S13CC_016MH**

Insp Date: **9/21/07 10:44 AM**

Location Address: **2900 WINCHESTER AVE**

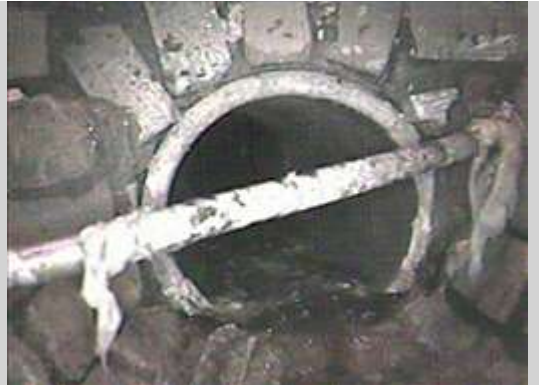
12 O'Clock Outflow

8 in. Circular Gravity Sewer
Pipe Out @ 12 O'Clock

Pipe Height: (in.) Direct
Pipe Material: **Clay** ☐ Pipe Lined
Invert Depth: **11.73** (ft.) Flow Characteristics: **Slow**
Deposits: ☒ None ☐ Mud ☐ ~~Gravy~~ ☐ Debris ☐ Grease
Silt Depth: (in.) Deposits Extent:
Infiltration: **None** Pipe Seal Cond: **Sound**

Drop: **None**

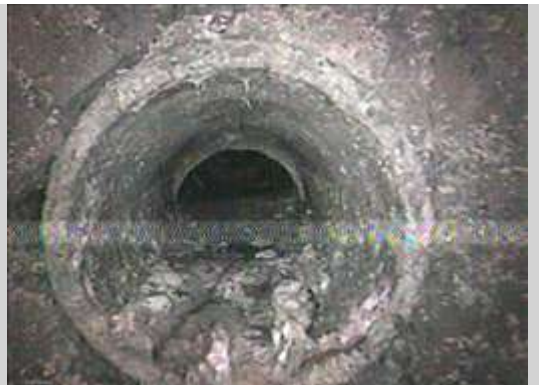
3 O'Clock Inflow

8 in. Circular Gravity Sewer
Pipe In @ 3 O'Clock

Pipe Height: (in.) Direct
Pipe Material: **Clay** ☐ Pipe Lined
Invert Depth: **9.37** (ft.) Flow Characteristics: **Slow**
Deposits: ☐ None ☐ Mud ☐ ~~Gravy~~ ☒ Debris ☒ Grease
Silt Depth: **2** (in.) Deposits Extent: **Light**
Infiltration: **None** Pipe Seal Cond: **Sound**

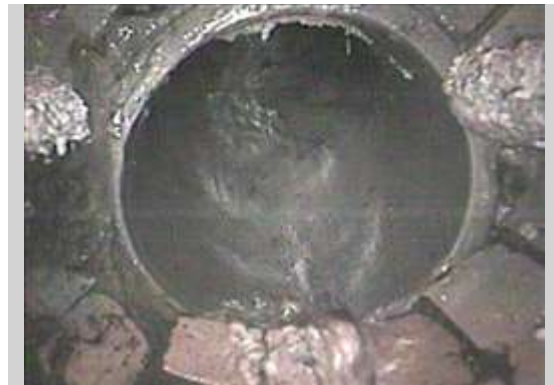
Drop In @ 3 O'Clock

Drop: **Outside Direct**

Inv Depth: **11.65** (ft.)

Drop Condition: **Open**

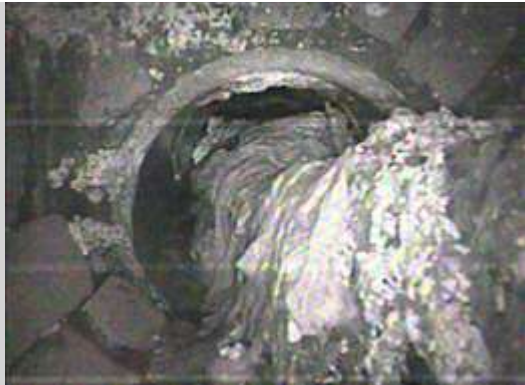
9 O'Clock Inflow

8 in. Circular Gravity Sewer
Pipe In @ 9 O'Clock

Deposits: ☐ None ☐ Mud ☒ **Sludge** ☒ **Debris** ☒ **Grease**

Silt Depth: **6** (in.) Deposits Extent: **Heavy**

Infiltration: **None** Pipe Seal Cond: **Sound**
